Death Depot

An investigative report documenting the explosion of an arms depot in a residential neighborhood in Sana'a

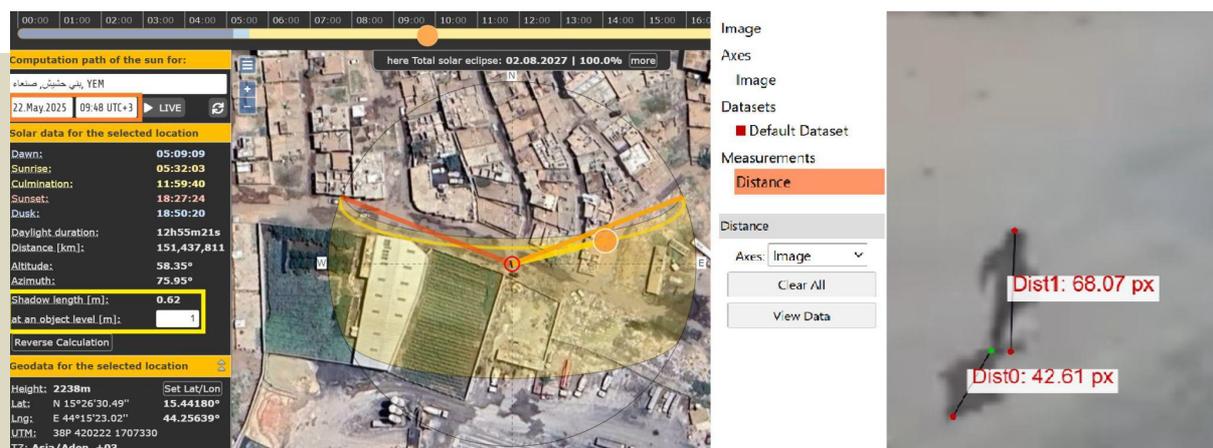
The explosion's timing was estimated by analyzing the shadow of a person visible in a [video](#) and matching it with relative height measurement equations. We captured a frame from the video showing the individual seconds before the explosion and measured the ratio of the person's shadow length to their actual height using the Automeris tool. The measurements showed that the shadow length was 42.61 pixels and 68.07 pixels, respectively. Based on the principle of proportionality, the shadow-to-person height ratio was determined to be 0.62:1, meaning that the shadow's length was 62% of the person's actual height.

Using the [Sun Calc](#) tool, we entered the previous values (shown in the highlighted rectangle in orange) to calculate the actual time of the video recording. We found that the video was captured at 9:48 AM (highlighted rectangle in orange).

This timing matches the accounts shared by [Facebook](#) users, who [reported](#) that three violent explosions occurred between approximately 9:50 AM and 9:55 AM.

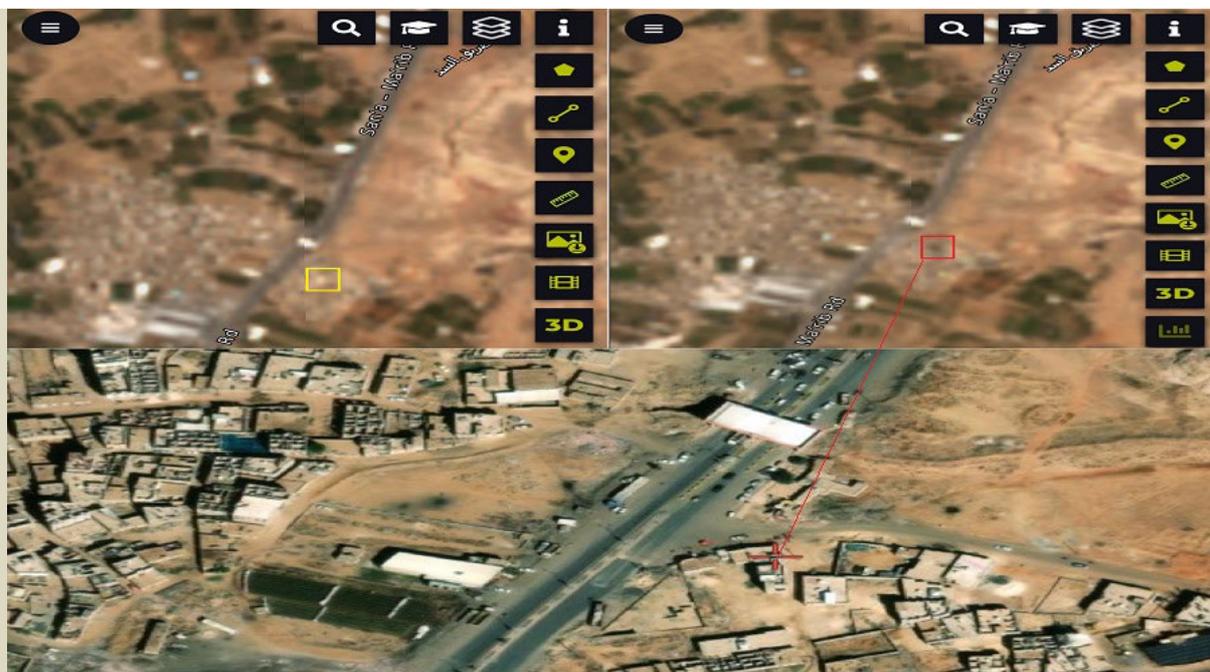
Satellite images from Sentinel Hub, available on May 24, 2025, showed the extent of the destruction caused by the explosion. The area highlighted in red marks the epicenter of the blast, which lies 60 meters southeast of the Khushm Al-Bakrah point, as confirmed by journalist and open-source intelligence specialist Farouq Moqbel Al-Kamali in a [post](#) on his Facebook page dated May 24.

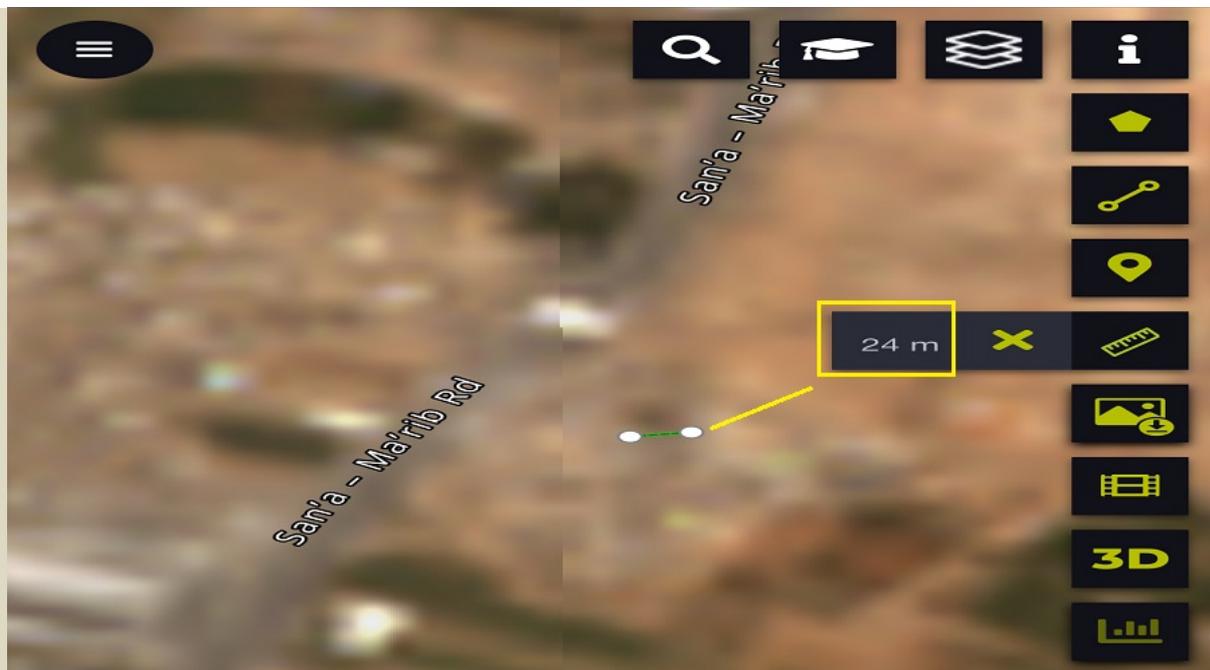
We determined the diameter of the explosion's epicenter, which ranged from 20 to 24 meters—the area directly impacted and completely destroyed. It's worth noting that the explosion's impact extended beyond 60 meters, meaning the level of destruction decreased with distance from the core, something not clearly captured by the available satellite images since the minimum diameter for the epicenter to appear clearly on the map is usually no less than 10 to 20 meters.

To estimate the approximate energy of the explosion, physical models were applied that correlate the size of the visible fireball with the destruction radius observed in the images. Assuming that the fireball, as seen in the explosion video, had an estimated diameter of about 20 meters, and that the destruction radius extended approximately 60 meters, this points to an estimated explosive yield ranging between 1,000 and 2,300 kilograms of TNT equivalent, with a weighted average around 1,500 to 2,000 kilograms. This is a significant amount of energy, consistent with the detonation of a warehouse containing large quantities of munitions or ballistic missile warheads.

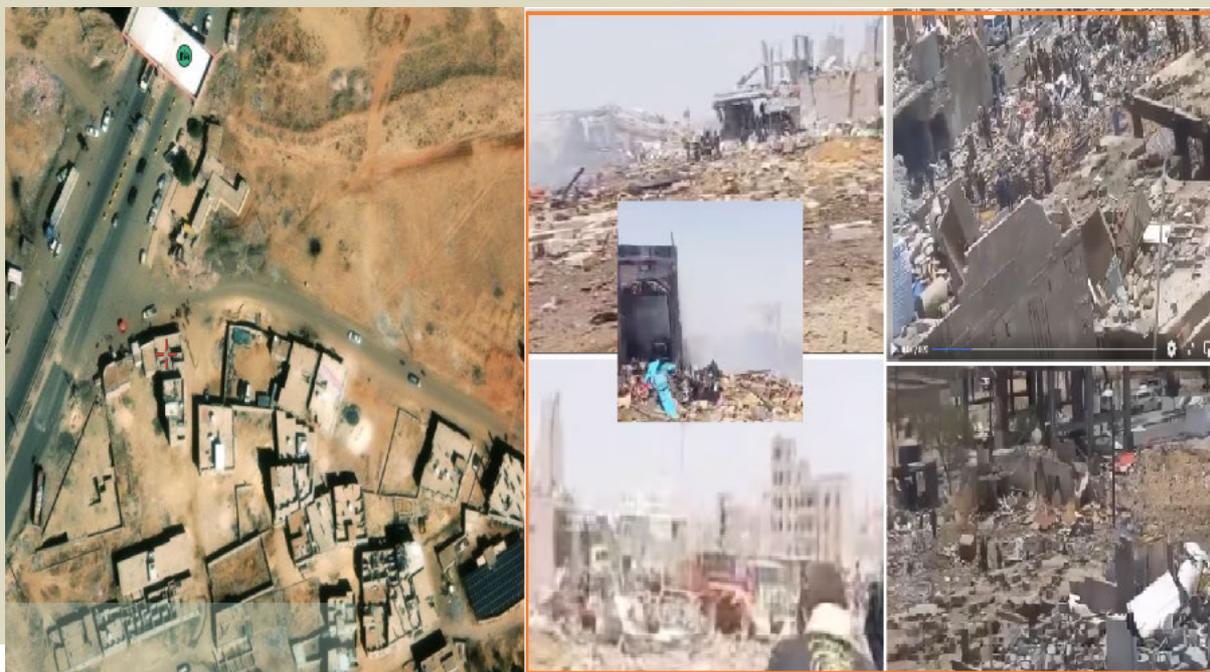
The available footage [shows](#) a stark contrast between the state of the area before and after the devastating explosion. On the left side of the visual comparison, the neighborhood appears in a clear aerial image, with neatly aligned buildings, well-defined streets, and a sense of calm daily life marked by order and stability. Homes stood solidly in their places with no signs of impending chaos or destruction. In stark contrast, the images on the right reveal the vast scale of [destruction](#) left by the arms depot explosion. Residential buildings and other structures were reduced to piles of scattered rubble, with the original landmarks of the area completely erased under the overwhelming force of the blast.

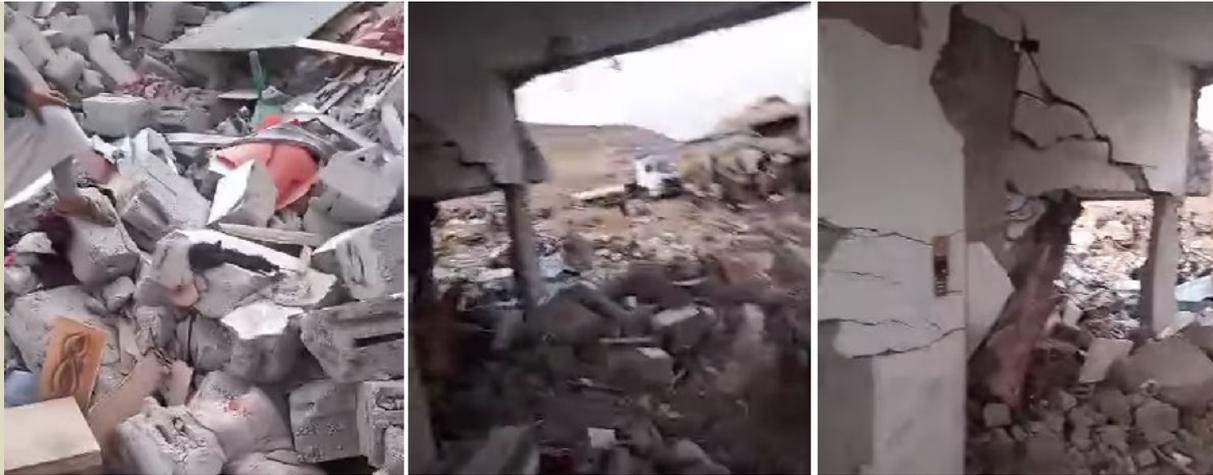
The extensive damage to Rashed Al-Kindi's [house](#) is clearly visible: the walls have completely collapsed, roofs have caved in, and concrete debris is scattered in every direction. The wreckage piles up, and among the physical remnants are torn personal belongings, shattered furniture, and other items that instantly lost their value and function in the moment of the blast.

Screenshots from a video show the destruction of Al-Kindi's home and grocery store

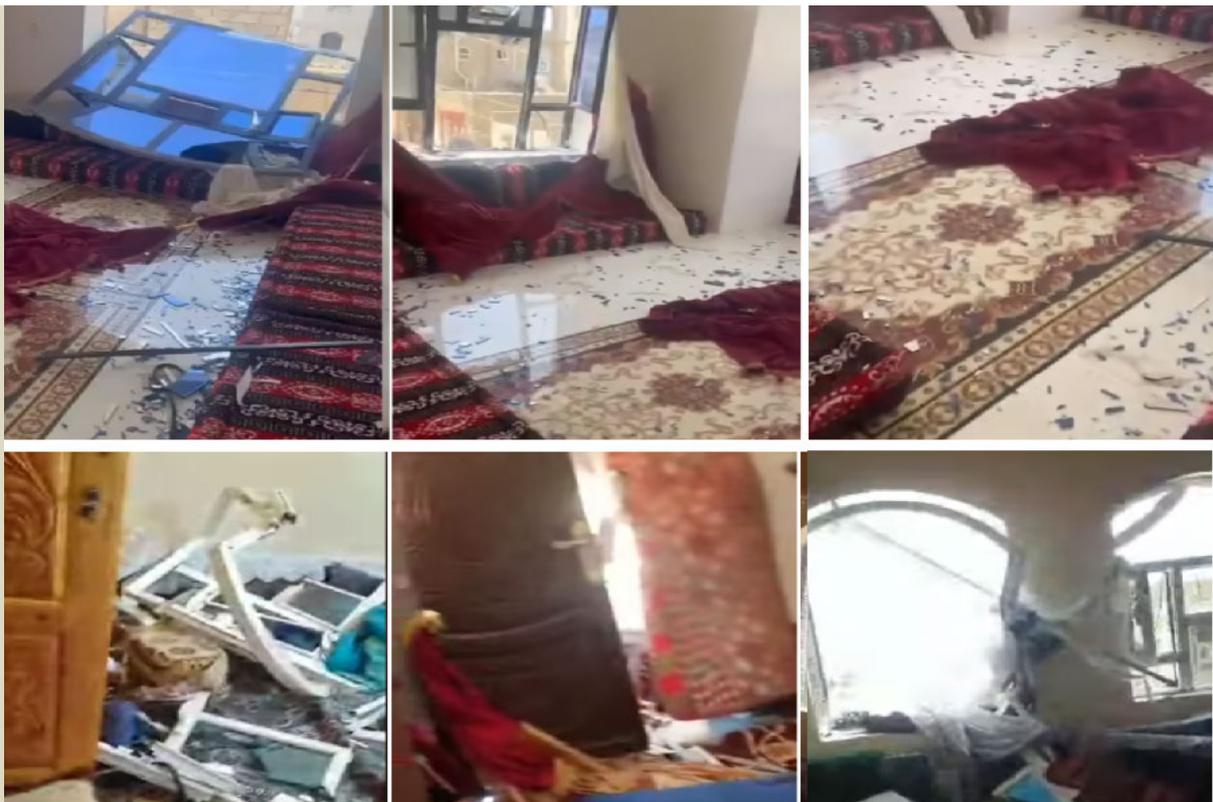
Even homes farther from the explosion's epicenter did not escape damage, with [shattered](#) windows and scattered [furniture](#) caused by the shockwave. The explosive force was enough to tear out even firmly anchored windows, highlighting the extraordinary strength of the blast.

Image shows damage to two houses as a result of the explosion

Using the Kingery-Bulmash [blast parameter calculator](#) and assuming an explosive charge equivalent to 1,000 kilograms of TNT, the calculated overpressure at a distance of 20 meters is approximately 221 kPa, with a reflected overpressure of about 1,329 kPa. At a distance of 60 meters, these values decrease to 8.2 kPa (incident overpressure) and 49.2 kPa (reflected overpressure), respectively. This explains why the most severe structural damage and injuries occurred within a radius of 20-30 meters from the explosion site. Beyond that range, the overpressure remains strong enough to shatter windows and cause minor structural damage, especially in older or poorly built homes.

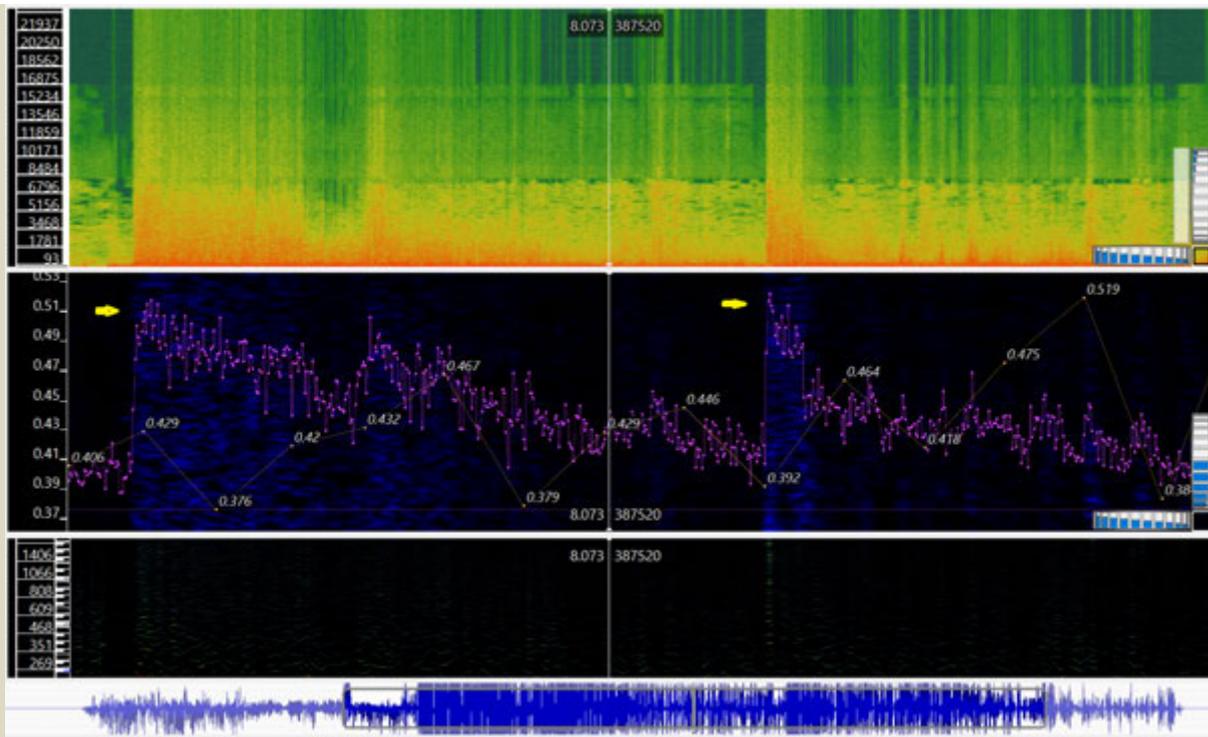
The spectral analysis of the explosion sound reveals the signature of military-grade munitions

The most striking feature in the upper part of the image is the wide spectral spread of the sound energy, which appears clearly across the entire frequency range, from low frequencies (93 Hz) to very high frequencies (above 20,000 Hz). This sharp and rapid energy spread is a distinctive sonic [fingerprint](#) of high-energy detonations, which is almost impossible to replicate with slow explosions or conventional fires.

The sharp peak at the beginning of the clip—seen in the lower graph as a sudden pressure wave followed by a rapid return to low energy levels—indicates a powerful and immediate shockwave. This pattern perfectly matches the behavior of military explosives like TNT or RDX/HMX compounds, which produce a very short-duration, extremely intense shockwave because of their high detonation velocity and near-instantaneous energy release. This differs from explosions involving ammonium nitrate or other slower oxidizing materials, which usually generate a less intense initial shockwave with a longer temporal tail—meaning the sound intensity remains high for a longer period before returning to normal, due to the slower chemical reaction and longer energy release.

According to analytical work by [Eric Salomons \(2024\)](#), the sound spectrum and waveform of high-energy explosions—such as those involving military explosives—display distinctive characteristics (like high-amplitude shock fronts and nonlinear expansion) that help differentiate between accidental fires and deliberate munitions detonations.

Moreover, the absence of recurring oscillations or secondary peaks after the main blast suggests there was no dense dispersal of metal fragments, which aligns with the nature of the depot, built from lightweight brick walls and a thin metal roof—structures that allow energy to escape quickly. [Gary S. Settles \(2006\)](#) demonstrated that “strong air shockwaves traveling at Mach 2 (680 m/s) produce overpressure peaks of several atmospheres, causing severe damage to structures and biological tissues. Reflected shockwaves in confined spaces can amplify these destructive effects.”

The spectral analysis reveals a sudden and sharp frequency shift at the moment of the explosion, with the shockwave waveform retained for a short time before quickly dropping, indicating a primary explosion rather than a sequential munitions detonation—supporting the likelihood of a unified warhead explosion.

It's worth noting that the recorded sonic fingerprint of the explosion—with an extremely rapid initial overpressure (positive shock front), an exponential decay phase, and a broad frequency spectrum spanning from infrasonic to high-frequency components—perfectly matches the acoustic properties described in the U.S. Department of Defense's acoustic fingerprinting [methodology](#) (standard 806-03). This provides additional scientific context for interpreting the audio evidence and supports the conclusion that the incident involved high-energy military munitions rather than low-energy industrial sources.

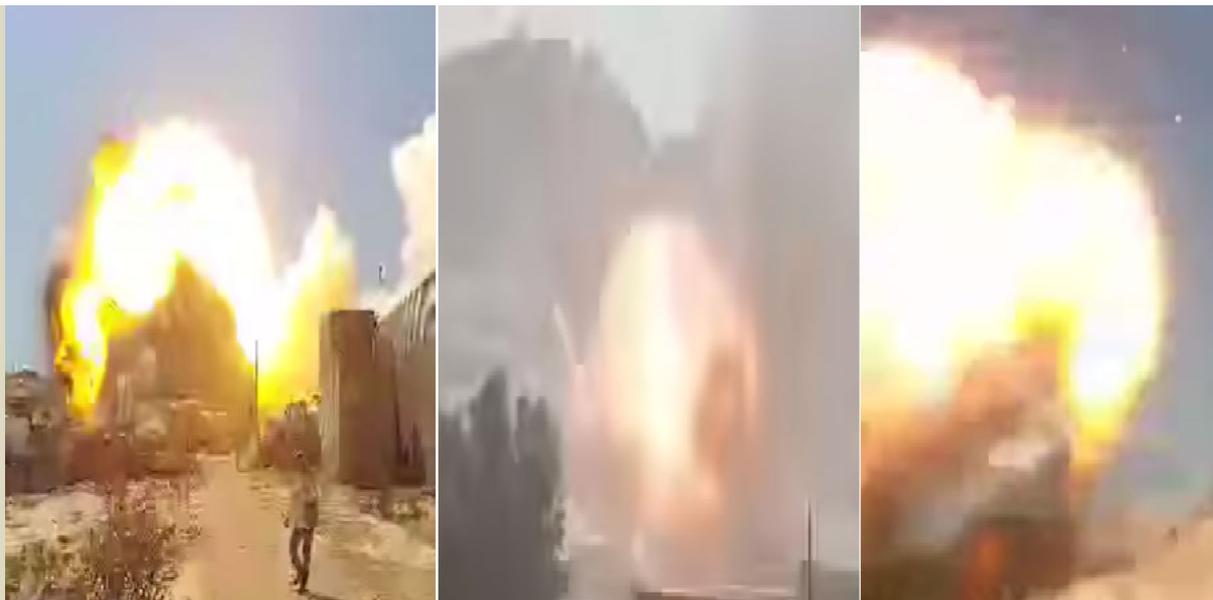
Screenshots from three different angles show a violent explosion with a strong fiery flash and thick white/gray smoke cloud, accompanied by intense dust agitation

The visible colors—a mix of bright yellow and white with orange and red edges—indicate the combustion of [high explosion](#), thermally intense materials, such as packed military explosives (TNT, RDX, or similar compounds). The type of explosive material appears to be consistent with conventional high-explosive [munitions](#), possibly including a short-range ballistic missile warhead. These warheads typically have unarmed fusing systems, but in some cases, the fuse or sensitive components can react to heat or electrical faults, triggering direct detonation without missile launch.

The absence of thick black or dark gray smoke in the initial moment suggests there were no petroleum-based or chemical rocket fuels involved, supporting the idea of a solid munitions explosion. While the possibility of rocket fuel combustion cannot be entirely ruled out, it's considered low to moderate, unless it was part of a warhead or stored propulsion unit with other explosive components.

Ballistic missile warheads usually contain compounds like HMX (Octogen) or RDX (Cyclonite), which are extremely sensitive and detonate with propagation [speeds](#) exceeding 1,000 m/s, producing extremely high heat and intense flame density with a sharp acoustic signature and intense white-orange fireball—exactly as seen in the attached video, unlike ammonium nitrate explosions, which produce brown or gray smoke clouds and do not create such fireball shapes.

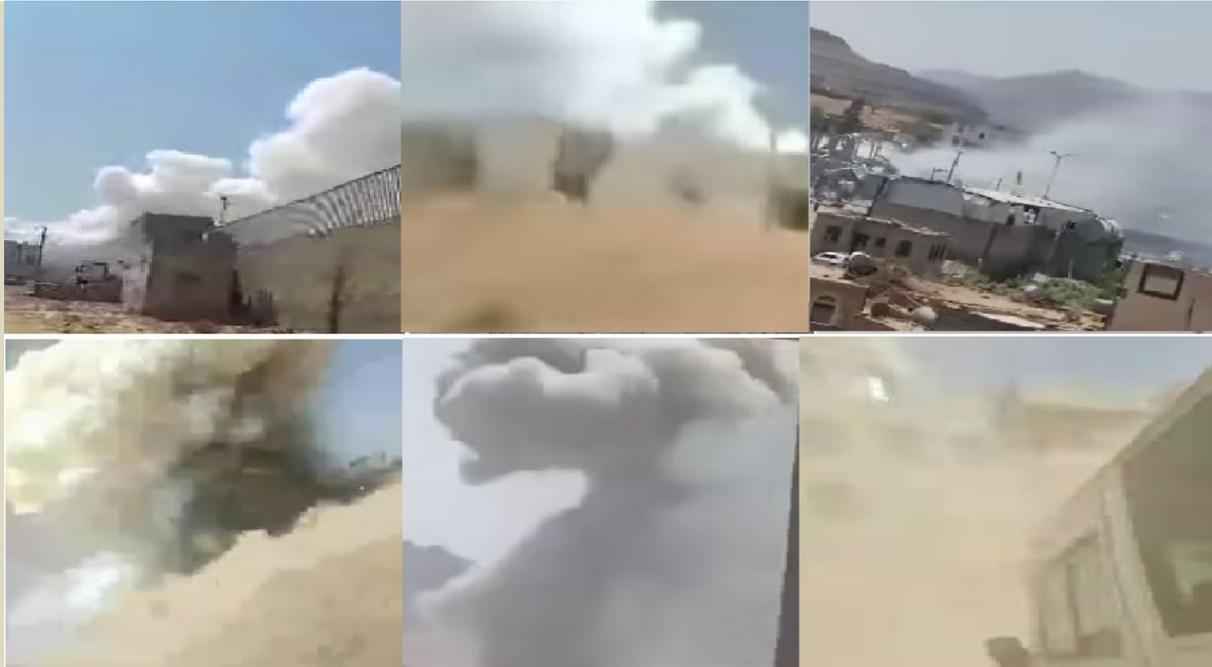
Screenshots highlight the smoke plume before and after the explosion

The images clearly show thick white smoke rising just before the blast, possibly indicating the start of a thermal leak or gradual ignition of propellant materials or primary charges within the warhead. Ballistic missile warheads usually contain highly explosive charges like TNT, HMX, or RDX, which can undergo a “deflagration to detonation transition (DDT)” if gradually heated, especially in poorly ventilated storage environments.

Some visual indicators (like the mushroom cloud and white/gray color) may be similar to ammonium nitrate explosions, but these alone are insufficient for conclusive differentiation, especially if the acoustic spectrum does not match the ammonium nitrate pattern.
